University of California, Berkeley  
Strawberry Creek  
Geomorphology- 2006 Status Report

March 2008  
Office of Environment, Health & Safety  
University Hall, 3rd Floor  
Berkeley, CA 94720

### **Geomorphology- 2006 Status Report**

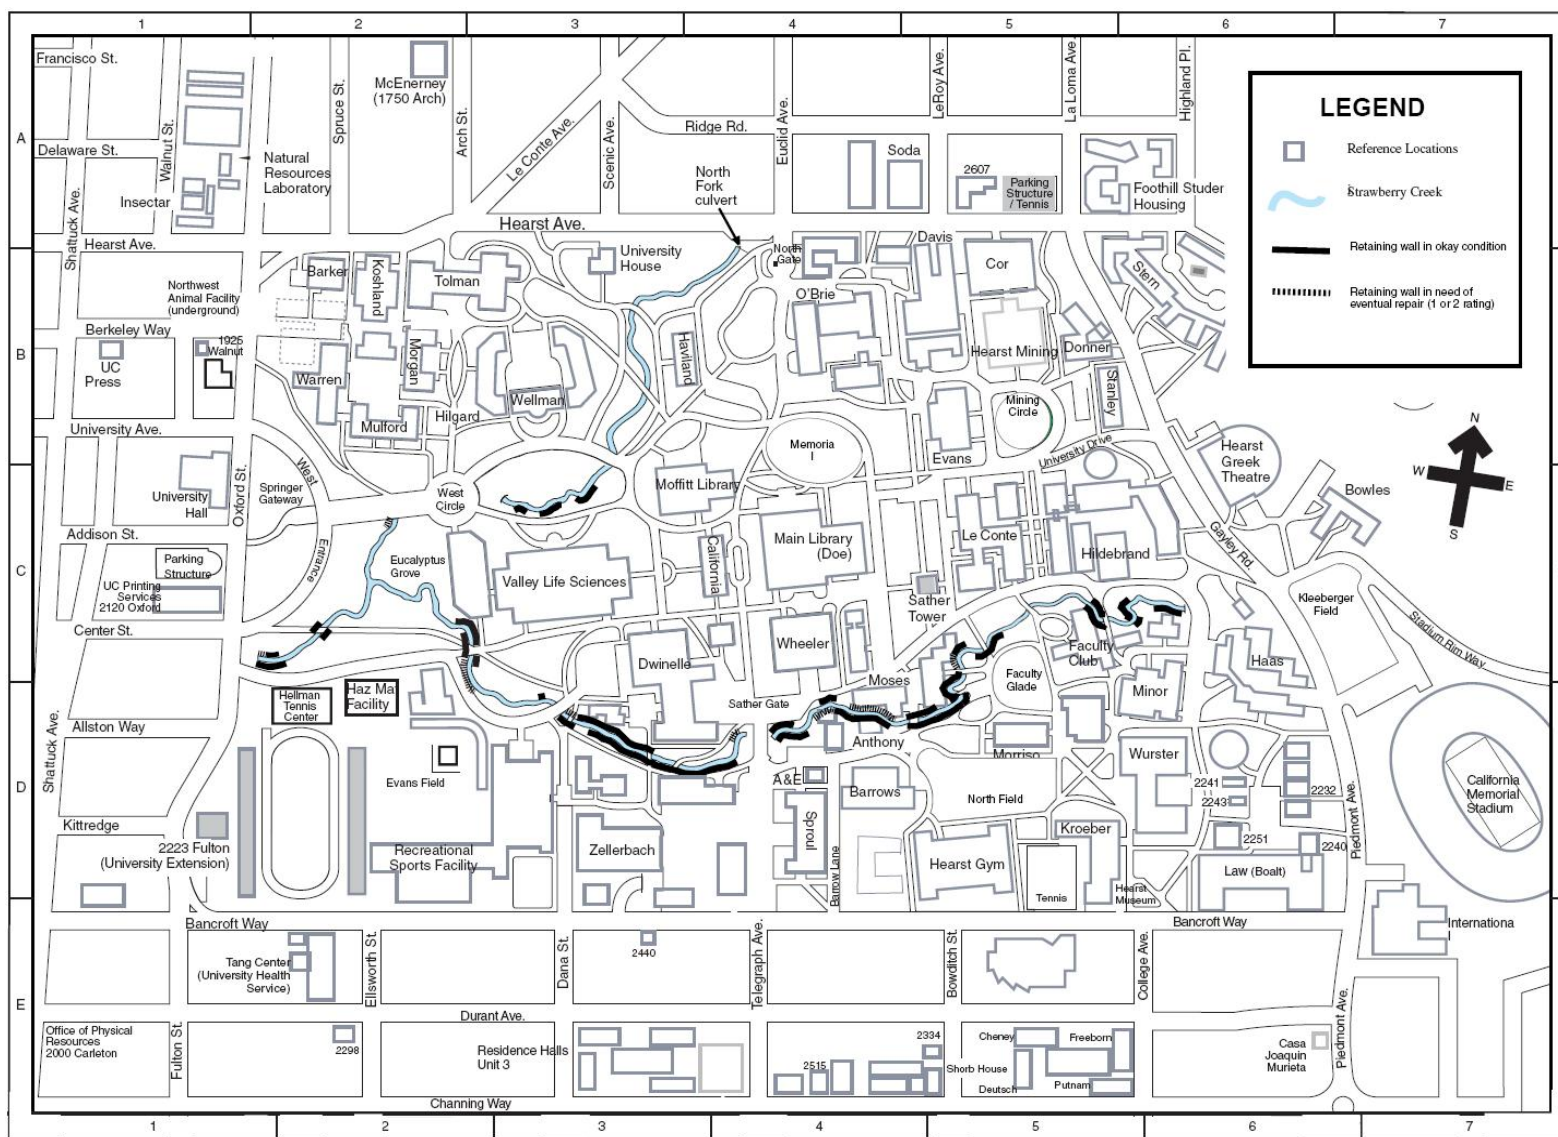
Figure 1. Retaining walls on Strawberry Creek, Central Campus. Dashed lines show walls in need of repair as identified by PWA (1999).

Many of the retaining walls on Central Campus are undercut, threatening the wall itself as well as buildings and infrastructure protected by the existing walls. In many of the areas where walls are undercut, remnant hardbed (that was intentionally removed or eroded over time) is also undercut. PWA (1999) documented retaining walls in need of repair in the immediate or near future as shown in Figure 1.

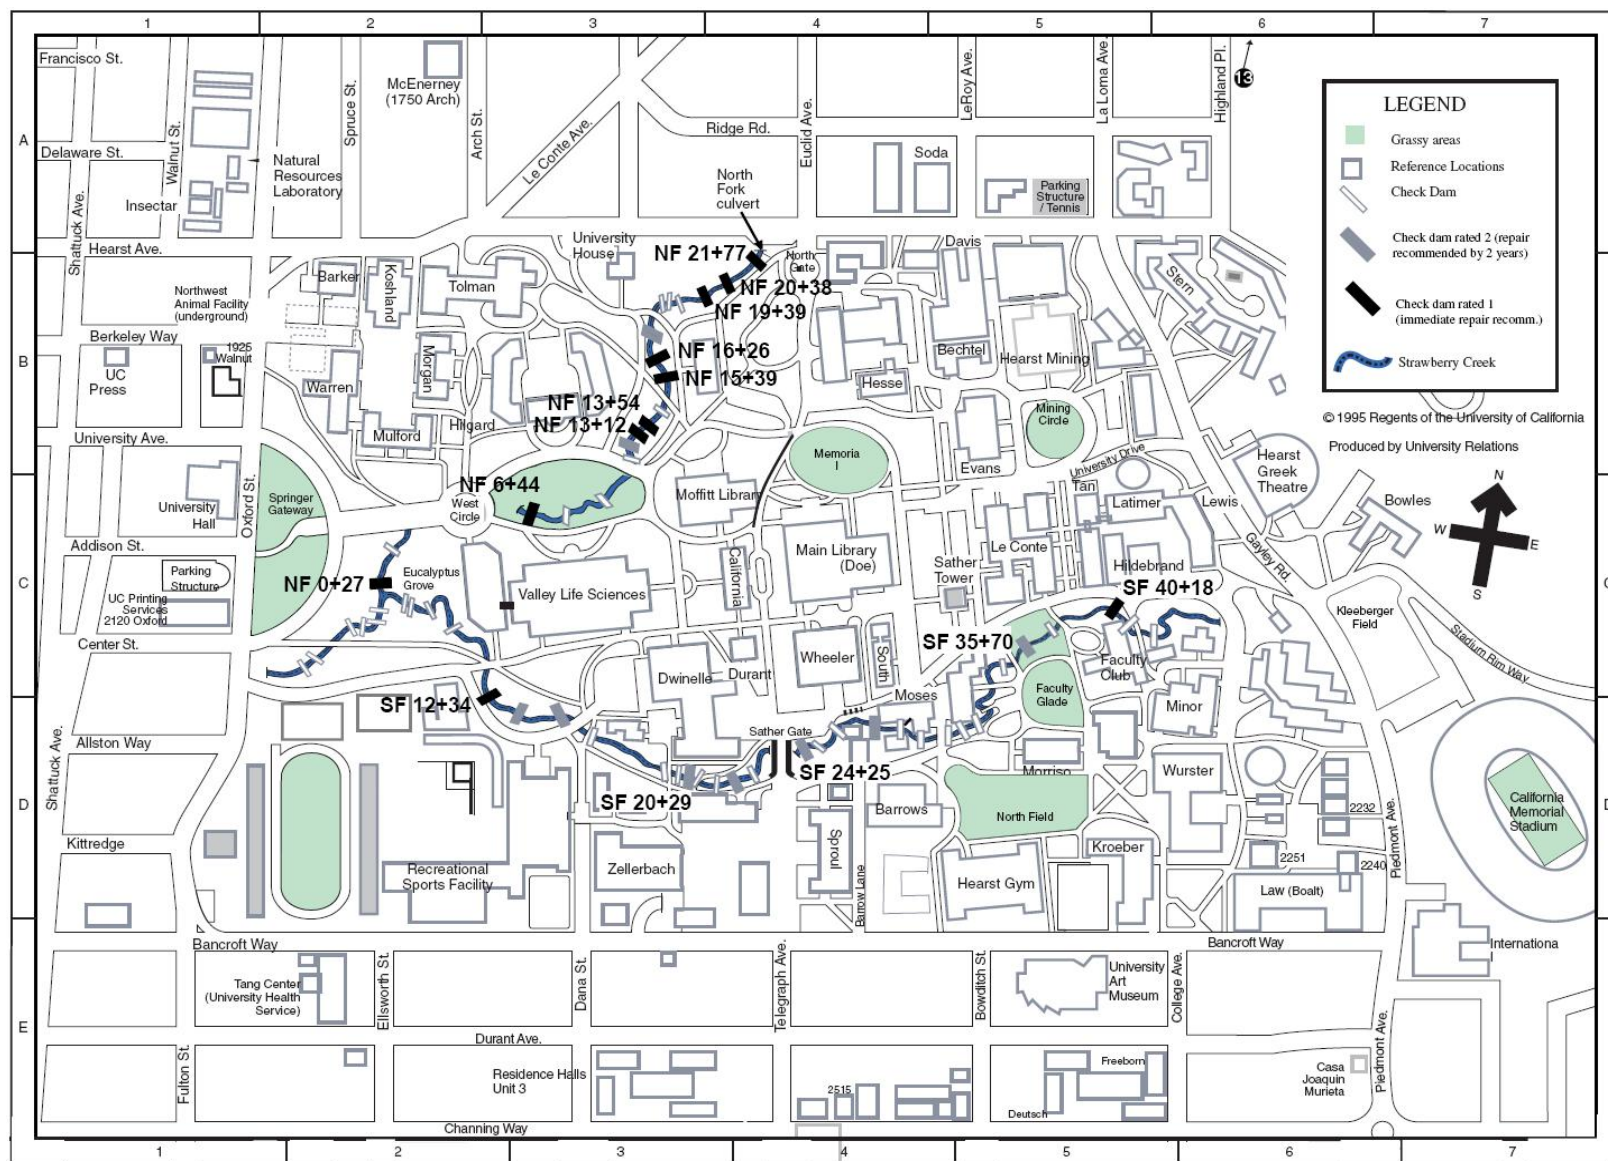
Figure 2. Check Dams on Campus. Check dams in need of imminent or future repair are shown larger than check dams in fair condition. (PWA, 1999)

cracking that could present future structural problems, and he determined that the remaining 32% had negligible damage. Maranzana found that the dams on the South Fork were relatively more structurally sound, with 17% showing severe damage, 14% showing moderate damage, and 69% with negligible damage. Maranzana (1998) identified 11 check dams that are in immediate danger of failure and should be repaired or replaced to avoid serious erosion, while PWA (1999) determined that 7 check dams on Campus should be repaired immediately. PWA identified 14 dams that should be improved over the next few years, and 3 in need of longer-term maintenance. PWA based their ratings on the condition of the structure as well as the consequences of structural failure. The check dams in need of immediate repair are shown on Figure 2 and detailed in Table 2 below.

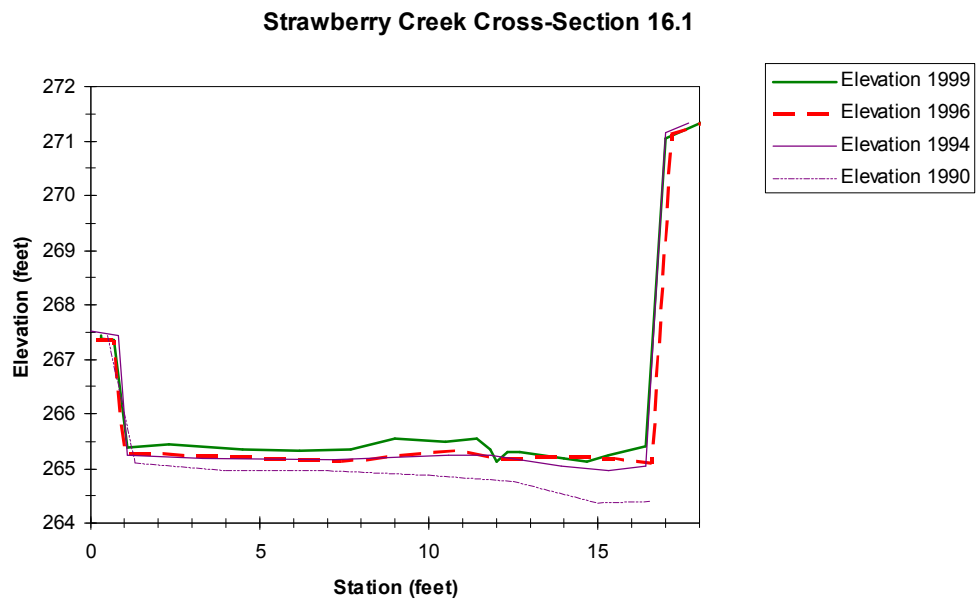
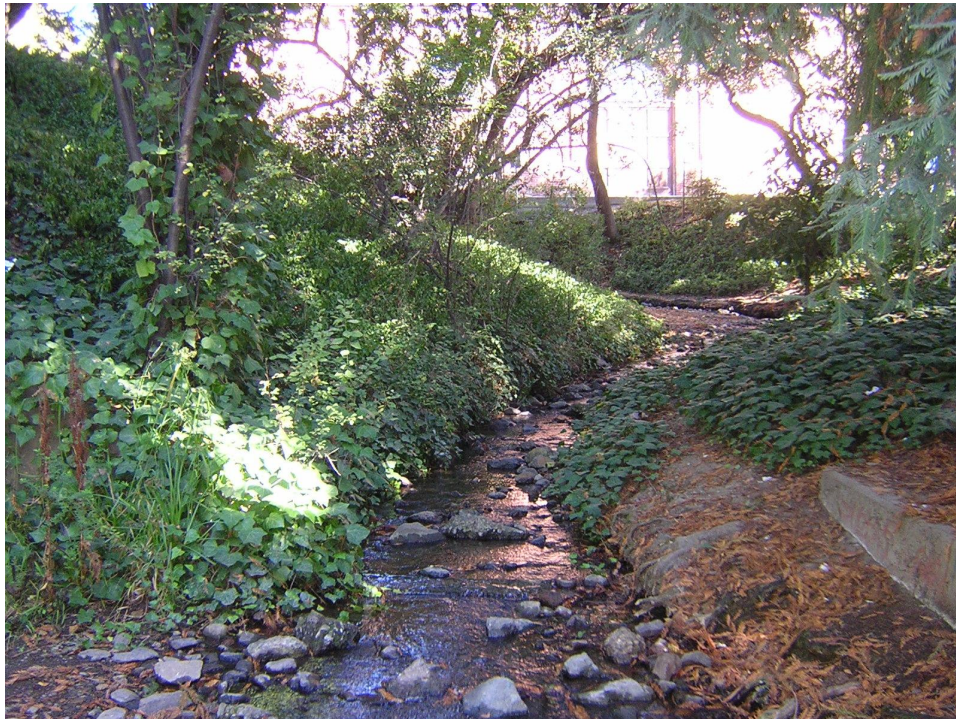
**Figure 4a.** Cross-section 16.1 on Strawberry Creek on UC Berkeley's Central Campus. 1990, 1994, 1996, and 1999. According to this data, the cross-section aggraded between 1990 and 1999. 1994 data from Morley, 1996 data from Maranzana, and 1999 data from Jain & Davis. Photograph taken October 2005, EH&S.

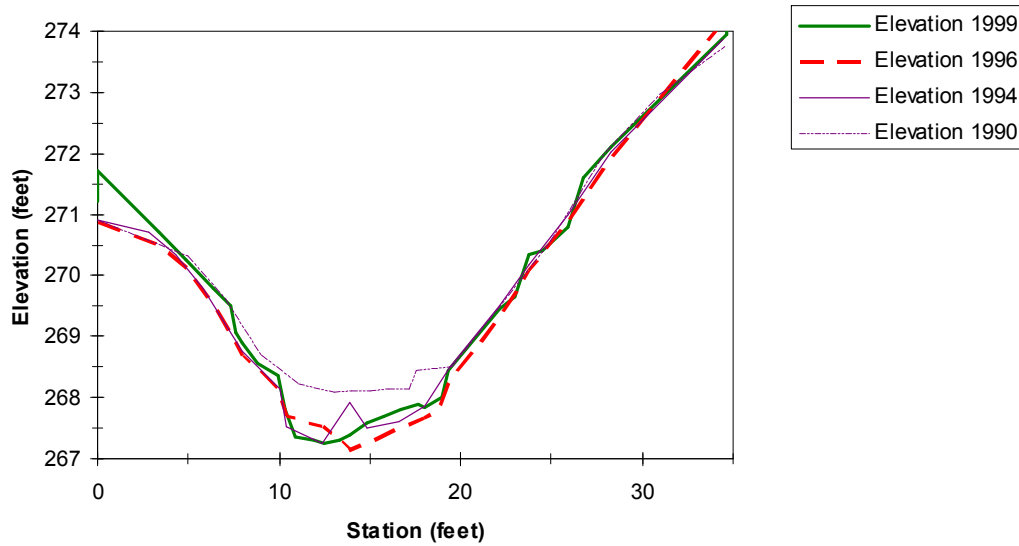
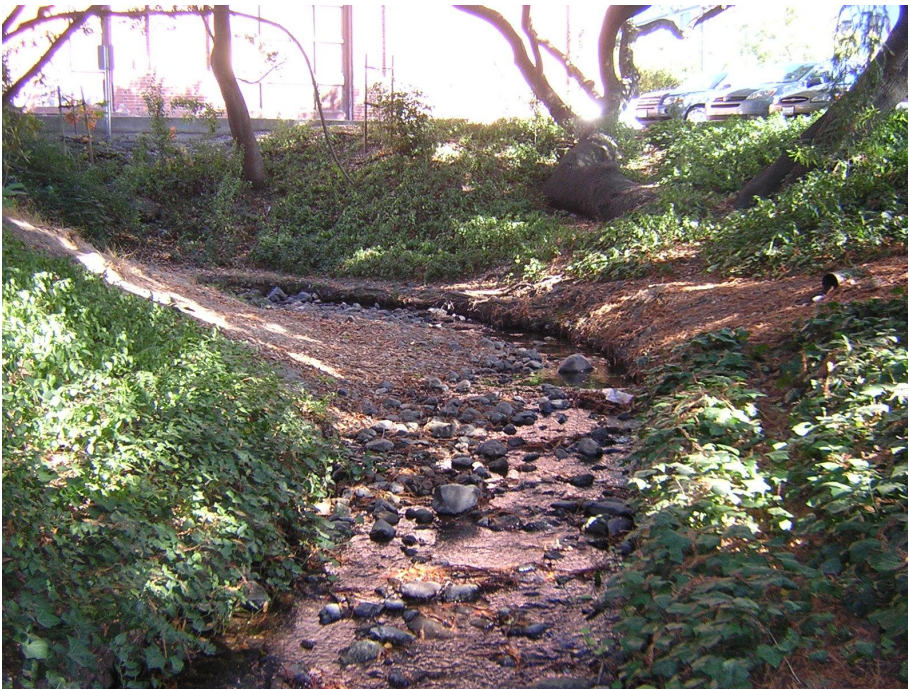
### Strawberry Creek Cross-Section 17.2

**Figure 4b** Cross-section 17.2 on Strawberry Creek on UC Berkeley's Central Campus. 1990, 1994, 1996, and 1999. The largest change was between 1990 and 1994, when the thalweg downcut about 1.5 ft. 1994 data from Morley. 1996 data from Maranzana, and 1999 data from Jain & Davis. Photograph taken October 2005, EH&S.

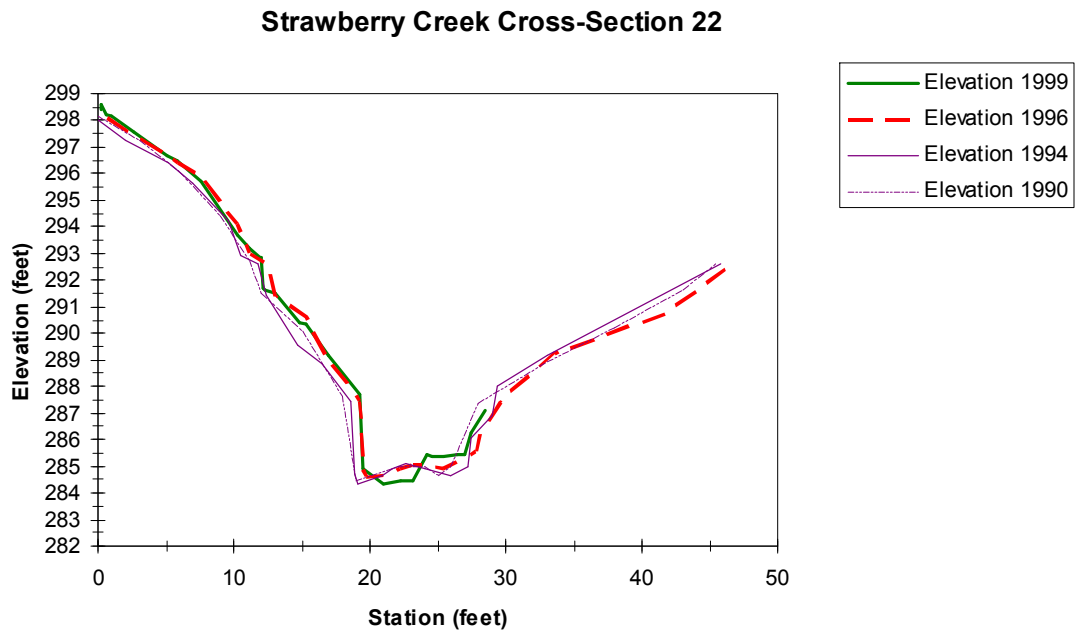
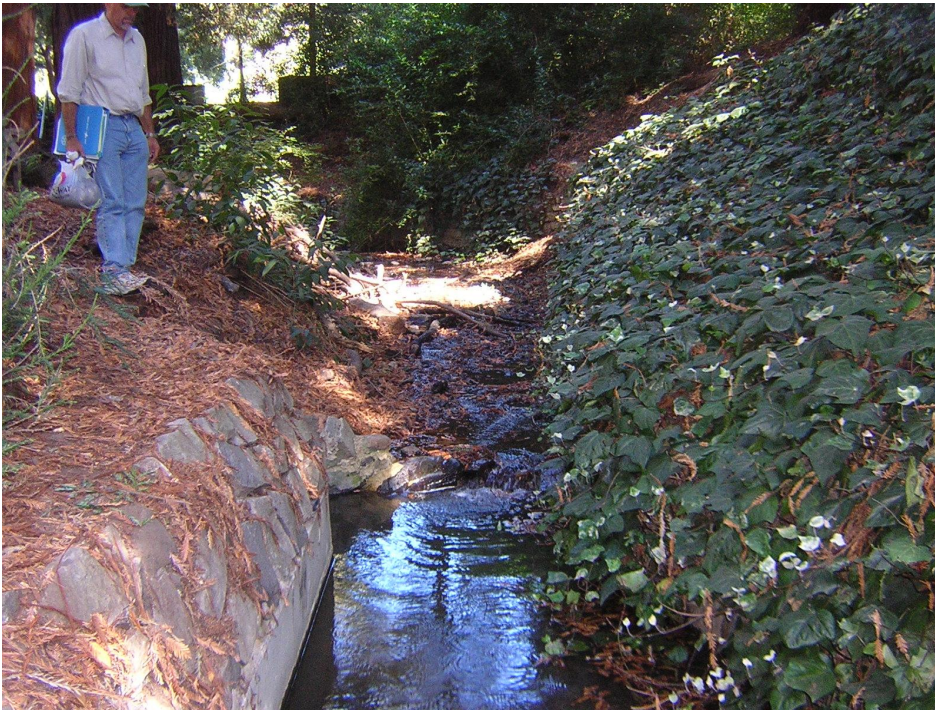
**Figure 4c** Cross-section 22 on Strawberry Creek on UC Berkeley's Central Campus. 1990, 1994, 1996, and 1999. 1994 data from Morley. 1996 data from Maranzana, and 1999 data from Jain & Davis. Photograph taken October 2005, EH&S.

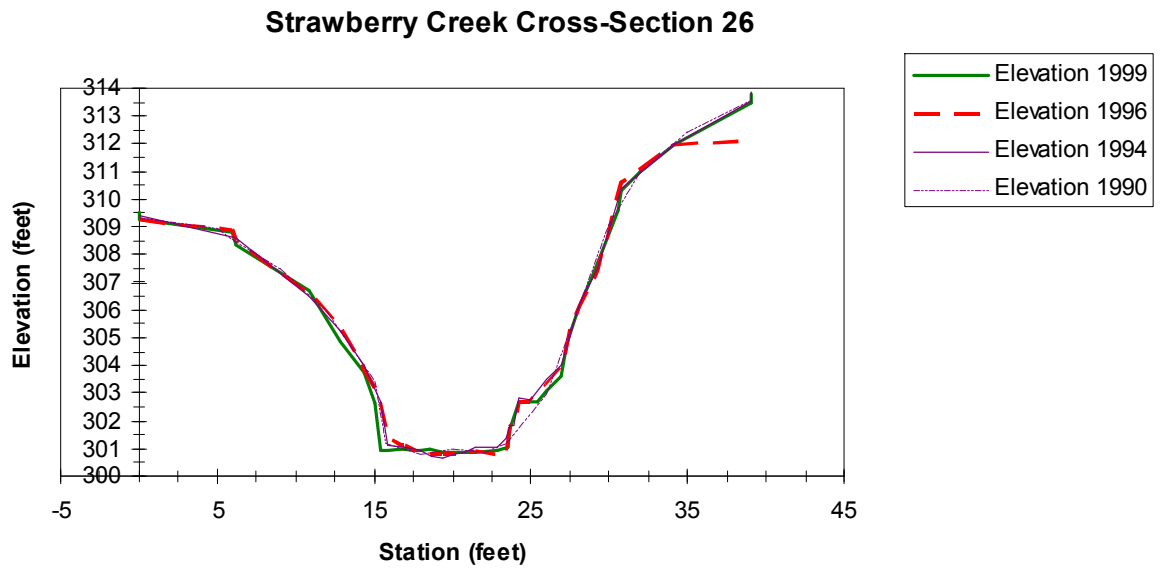
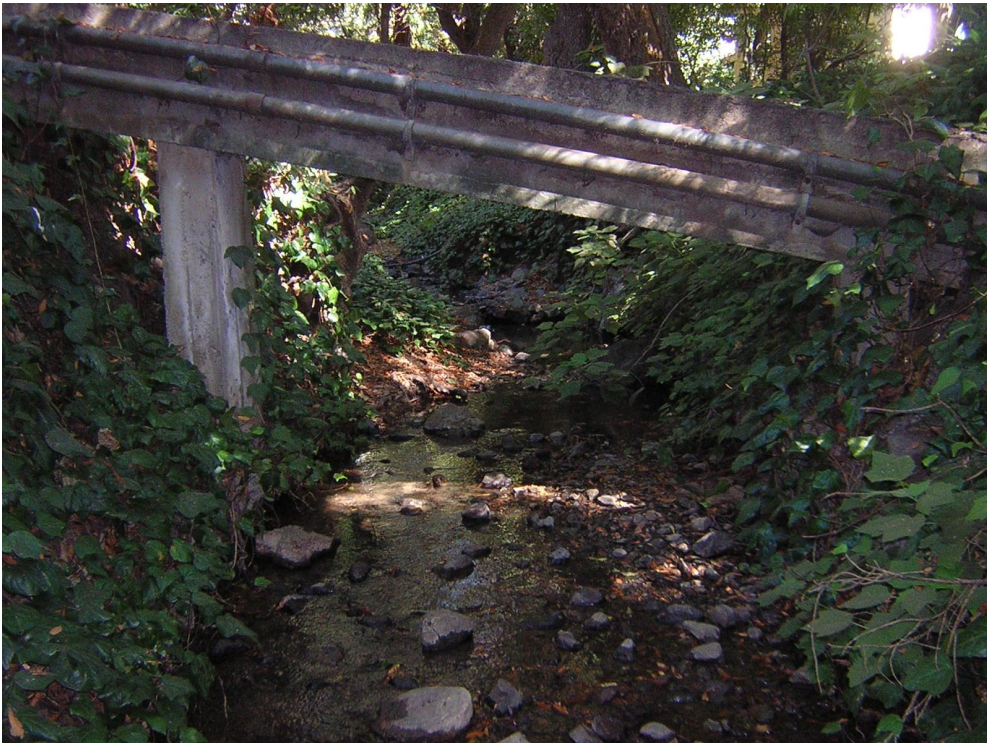
**Figure 4d** Cross-section 26 on Strawberry Creek on UC Berkeley's Central Campus. 1990, 1994, 1996, and 1999, showing almost no change between 1990 and 1999. 1994 data from Morley. 1996 data from Maranzana, and 1999 data from Jain & Davis. Photograph taken October 2005, EH&S.

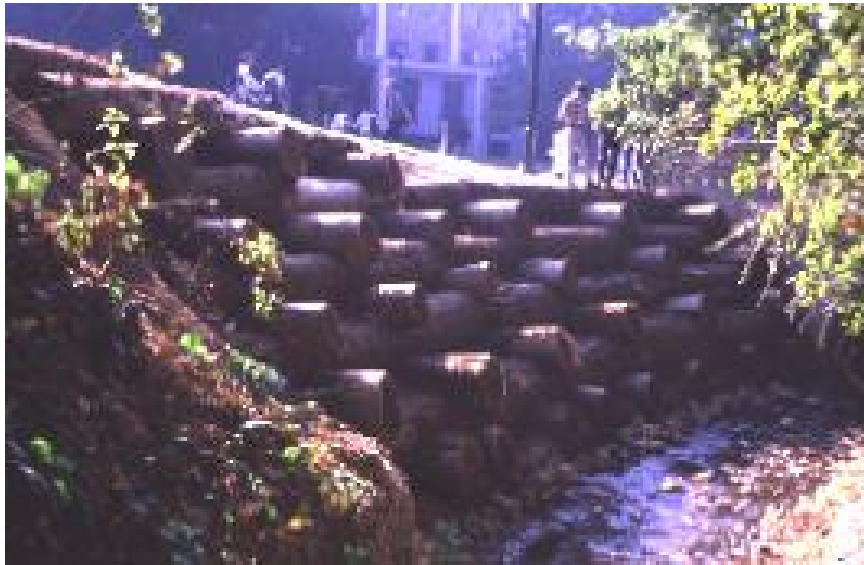
Redwood cribwall near Stephens Hall

Near the redwood cribwall, Charbonneau and California Conservation Corps workers intentionally removed some sections of hardbed to increase habitat value in the area. Otherwise, all hardbed sections remain unchanged.
