University of California, Berkeley Strawberry Creek Biological Resources- Flora and Fauna 2008 Status Report

February 2008 Office of Environment, Health & Safety University Hall, 3rd Floor Berkeley, CA 94720

This status report provides a summary current conditions of the biological resources of the Strawberry Creek ecosystem on the University campus. This is one of a series of technical reports being issued by the EH&S to commemorate the twentieth anniversary of the restoration program.

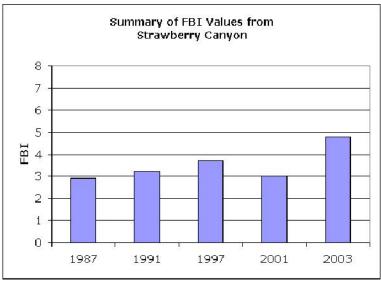
Table 1: FBI values from Strawberry Canyon, 1987-2003

Figure 1. Graphic Summary of Family Biotic Index values from Strawberry Canyon between 1987 and 2003

The results of the periodic Family Biotic Index surveys indicate that Strawberry Canyon has consistently exhibited the best water quality. Between 1987 and 2001, the Canyon site consistently exhibited the most favorable Hillsenhoff rating ("excellent"). This relatively protected site is not subject to the same urban stresses that many of the downstream reaches continually experience. However, in 2003 the water quality at the Canyon site was found to have deteriorated from "excellent" to merely "good." This is not a devastating shift; however, it is notable change from historically better findings. This change may have been caused by siltation due to construction runoff in the upper canyon area or from increased runoff into the Winter Creek tributary. Siltation and mineral loading can negatively affect biological communities and water quality (Charbonneau, 2000).

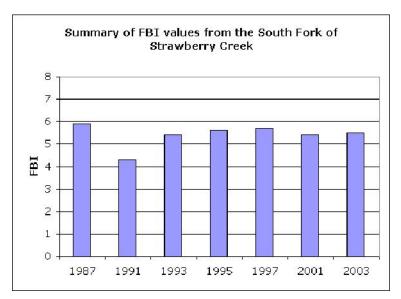
Table 2: FBI Values from South Fork, Central Campus, 1987-2003

Figure 2: Graphic Summary of Family Biotic Index values from the South Fork of Strawberry Creek on Central Campus between 1987 and 2003.

The South Fork, although consistently of lower habitat and water quality than the Canyon site, has been less degraded than the North Fork through out its recorded history. Results from the South Fork demonstrate the effectiveness of improvements from relatively easy operational changes made during the beginning of the restoration program. In 1987, prior to restoration the South Fork was rated as "fairly poor." At this time the South Fork received a significant amount of pollution from various sources: latrines at Memorial Stadium, campus buildings (cooling water, laboratory and machine room drainage) and construction sites. However, records from monitoring indicate that after the implementation of the SCMP in 1987, the South Fork had improved water quality and significantly better habitat conditions than the North Fork. The year 1991 marks the first visible results of the restoration efforts made possible by the implementation of the SCMP. The improvement in water quality on the South Fork (from "fairly poor" to "good") can most likely be attributed to the SCMP's simple yet immensely effective strategy to eliminate point sources of pollution.

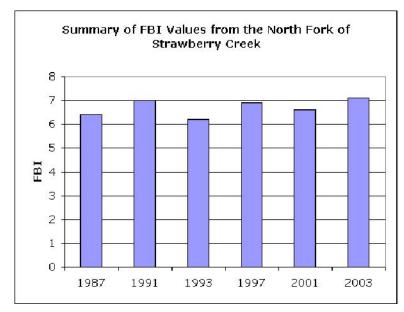
Table 3. FBI values from North Fork, Strawberry Creek, 1987-2003

Figure 3: Graphic Summary of Family Biotic Index values from the North Fork of Strawberry Creek on Central Campus between 1987 and 2003.

Unfortunately, the North Fork of the creek did not experience the same boost in water quality. Because of its steep downhill slope and its proximity to Hearst Avenue, the North side of the UC Berkeley campus is highly prone to non-point source urban runoff. Urban development has created a higher percentage of impermeable area in the North Fork watershed than the South Fork. During the wet season, flash torrents of water drain from the street and surrounding area. This urban pollutant laden runoff can cause "shock loading" upon entering Strawberry Creek (Charbonneau & Resh, 1992). Because of this combination of unfavorable conditions, it has proven to be more difficult to restore the habitat in the North Fork of the creek than the South Fork. The North Fork is also prone to more spill events, such as sewer overflows and water main and fire hydrant breaks, due to the greater urban development along this branch, and because a large portion of the north east quadrant of campus drains to the creek via the cross-campus culvert. These spills can have a devastating affect on aquatic life and full recovery can take years.

The North Fork is currently recovering from two recent, large spill events. In March 2002, a subcontractor involved in Hearst Memorial Mining Building construction backed a truck into a fire hydrant. Water from the high-pressure water main spilled into the underground steam-heating system, was heated to 125°F, then flowed into the creek's north fork (UC Berkeley News, Berkeleyan, 22 October 2003). The discharge of hot, silted and chlorinated water killed nearly all of the aquatic life on the North Fork downstream of the Mining Circle Creek culvert (also known as the Cross Campus Culvert or CCC). By 2003 the creek had begun its recovery, but was further impacted from a water main break from off campus that flowed into the creek overnight for fourteen hours, decimating fish populations and probably further impacting invertebrates due to chloramine exposure. The results from monitoring performed in fall 2003 indicate that its habitat and water quality were more degraded than they had ever been since 1987.

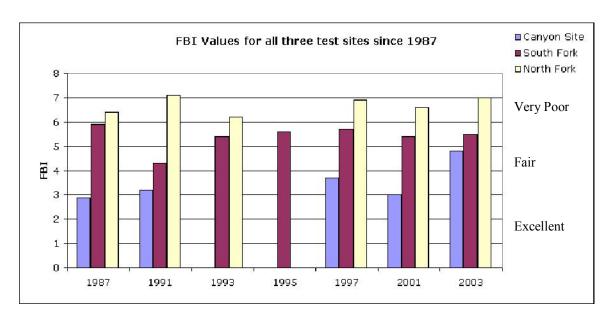
Figure 4: Graphic Summary of Family Biotic Index values from the Canyon Site, the South Fork, and the North Fork of Strawberry Creek.

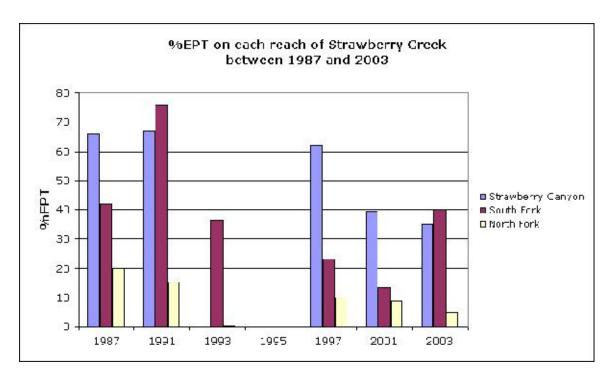
Figure 5: %EPT on each reach of Strawberry Creek between 1987 and 2003.

The metrics %EPT and Number of Families are both relative measures. They are useful in determining which reach is healthiest, relative to the other reaches. However, at this time, there is no scale which dictates a stream's degrees of health based on established standards.

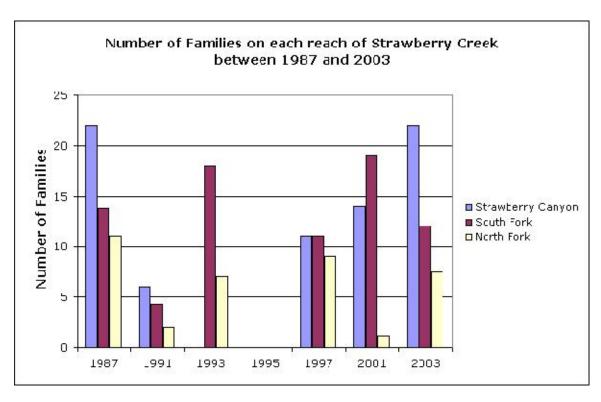
Figure 6: Number of Families on each reach of Strawberry Creek over time.
