University of California, Berkeley  
Strawberry Creek  
Geomorphology- 2006 Status Report

March 2008  
Office of Environment, Health & Safety  
University Hall, 3rd Floor  
Berkeley, CA 94720

### **Geomorphology- 2006 Status Report**

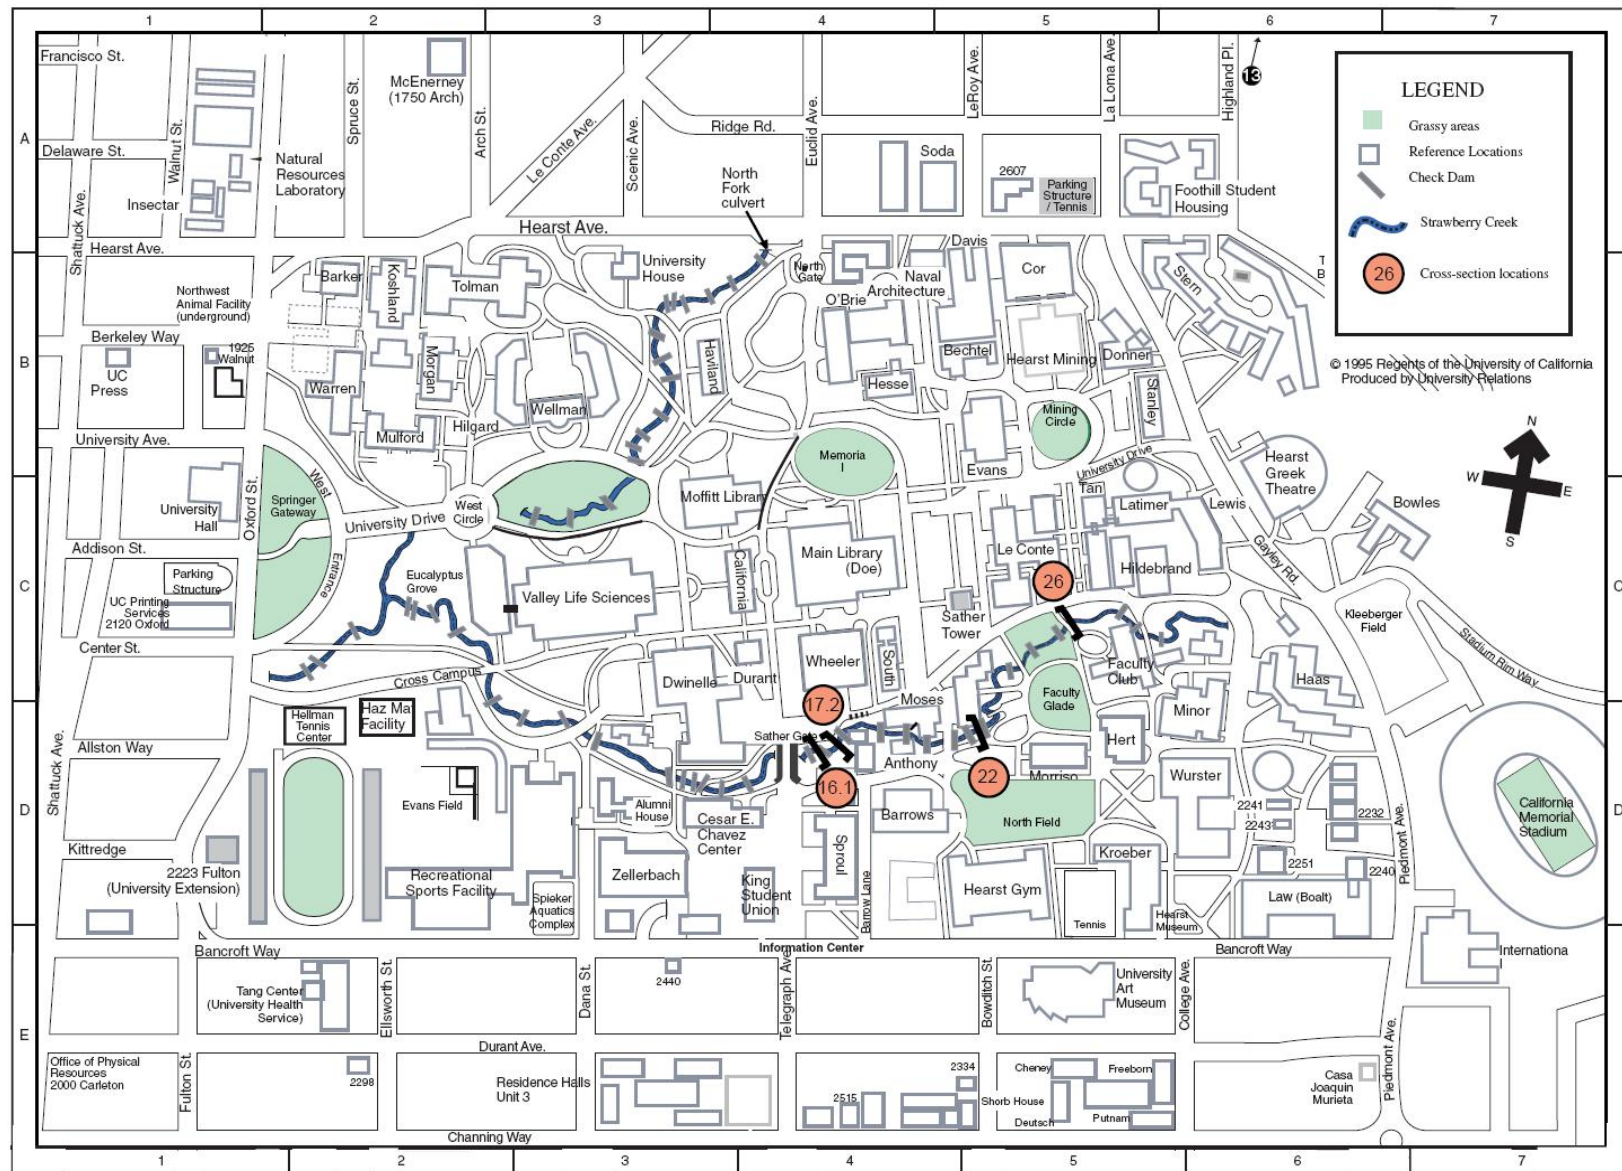
Figure 3. Strawberry Creek cross section sites. Individual cross sections are shown in Figures 4a-d

These four cross section sites, surveyed four times each over 10 years, show several areas of the creek that have changed little or not at all during this time period. All of these cross sections are located on the South Fork in heavily armored areas of the channel, where significant measures have been taken to stabilize the channel with concrete banks and check dams. These cross sections represent stable areas of the creek that currently require little or no channel maintenance, though there are other reaches that are in significant danger of failure or damage.
